**PHASE I / PHASE II ENVIRONMENTAL ASSESSMENT  
CLINTON ENGINES PROPERTY  
605 EAST MAPLE STREET  
MAQUOKETA, IOWA**

**CITY OF MAQUOKETA  
201 East Pleasant Street  
Maquoketa, Iowa 52060**

**MISSMAN, STANLEY & ASSOCIATES, P.C.  
2415 18<sup>th</sup> Street, Suite 203  
Bettendorf, Iowa  
(319) 344-0260**

**October 15, 1999  
C99E028**

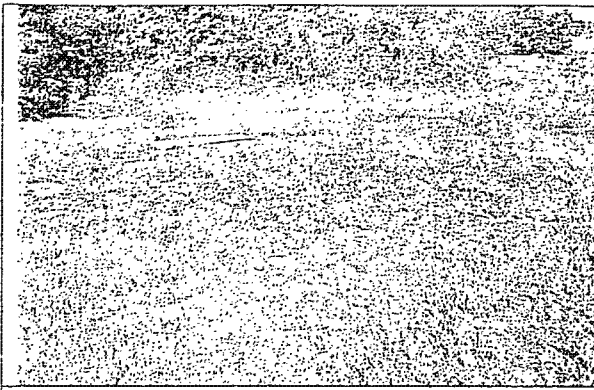
Stressed vegetation located on the north side of the main structure.

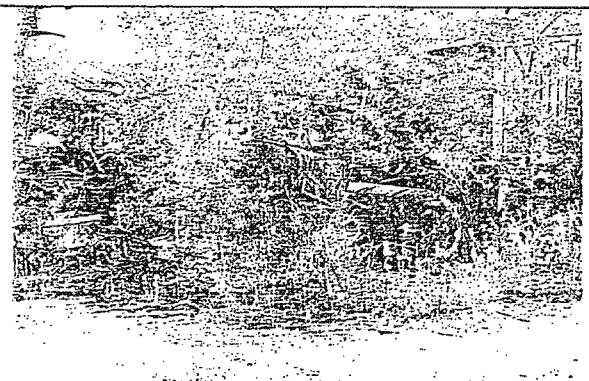
A view of drums located on the south side of the easterly building.

- Several areas inside structures on the property contained residual chemical containers, staining, discoloration and waste material. These areas should be addressed prior to demolition of the structure.

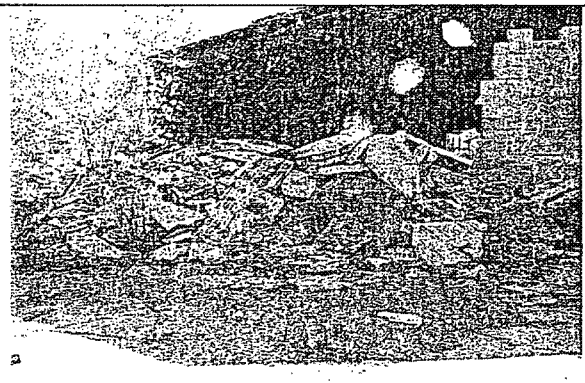
A shipping and staging area and a former foundry were east of the central portion of the structure. This section was vacant, however remnants of electrical equipment, wood, metal debris, various fifty five gallon drums, electrical motors, pumps, light ballast and pressure tanks were observed. East of the foundry, large blocks of concrete and brick were scattered about on a concrete pad. This appeared to be remnants of a former building. Two other, mostly vacant

Concrete debris located immediately east of the foundry structure.
